The Martian Landscape

By The Viking Lander Imaging Team

Scientific and Technical Information Office
NATIONAL AERONAUTICS AND SPACE ADMINISTRATION
Washington, D.C. 1978

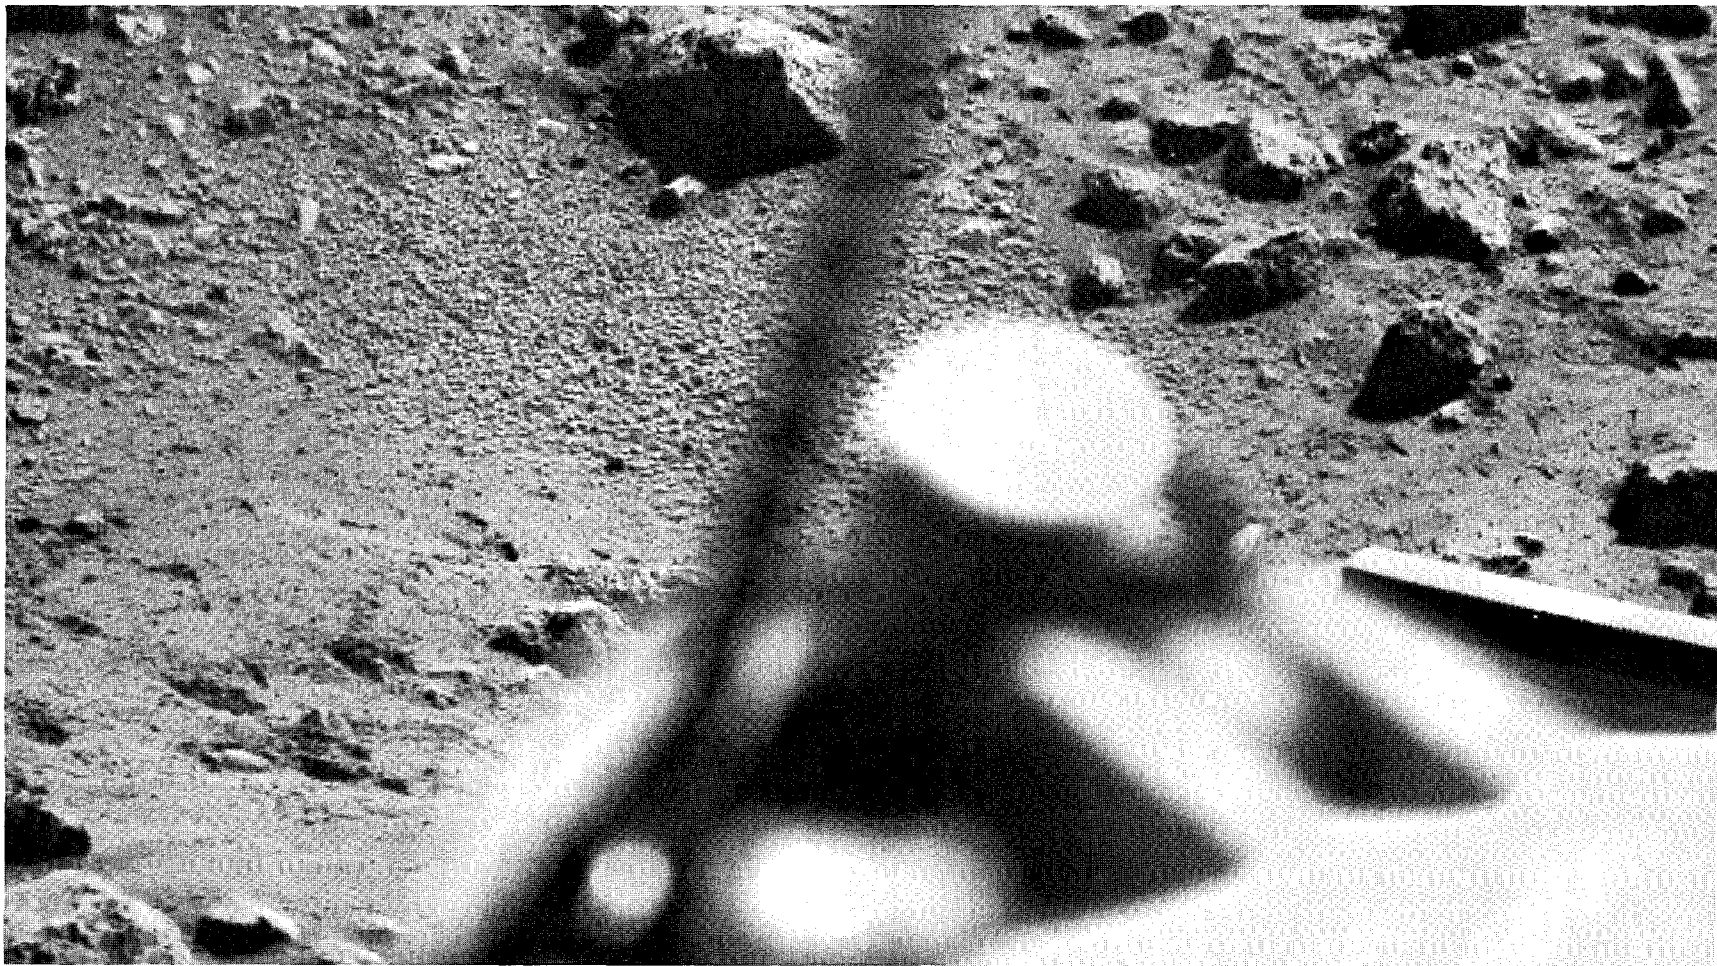
FIGURE 61

Figures 60 and 62 are two pictures of the same area taken under different lighting conditions, although figure 60 shows a larger area than does figure 62. Figure 61 is an enlargement of the area in the upper right corner of figure 60. Pits formed by throwout of soil pellets during landing rocket maneuvers are particularly well displayed in the right side of figure 62. At the far right of figure 61, just above the landing leg strut, a beer-can-shaped object is visible lying on the

surface. This is a shroud that protected the surface sampler head and was ejected after landing, bouncing, and rolling to its present position. The apparent coarse texture of the sediment in the upper left of figure 61 may be an artificial effect, caused by "aliasing." Aliasing results when periodic small-scale brightness variations in the scene cause systematic variations in larger picture elements.

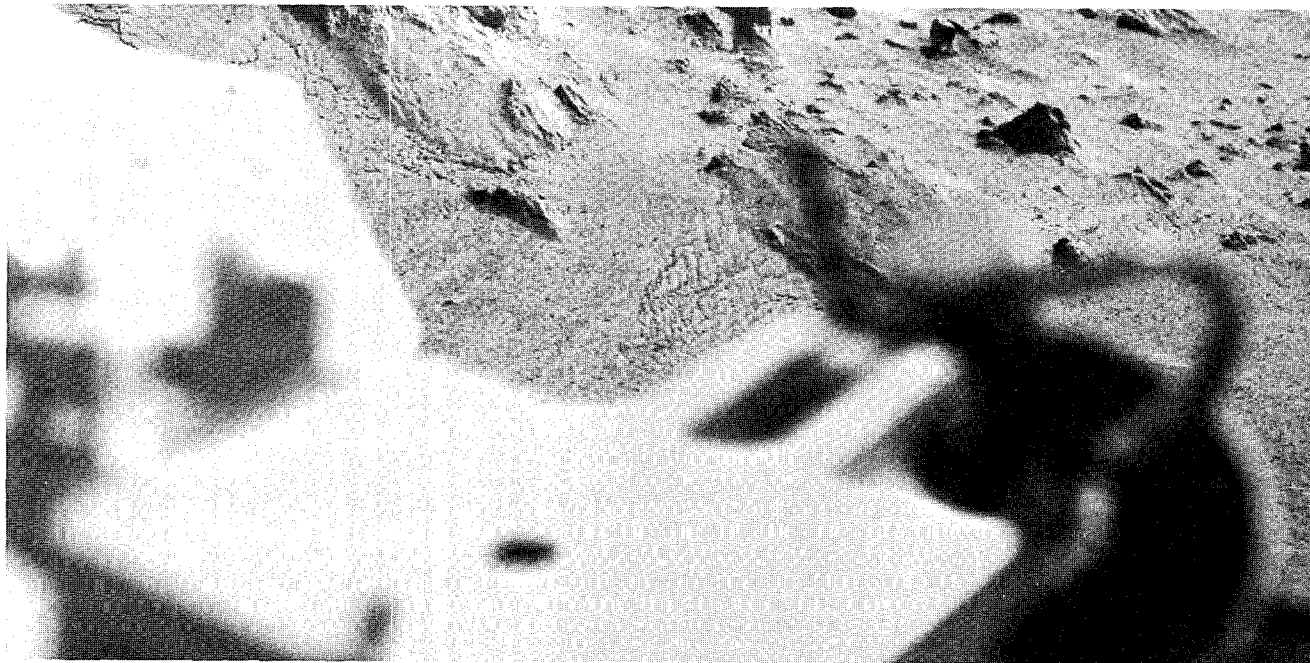
FIGURE 63

Figure 63 shows a rectilinear set of ridges and cracks in fine-grained material. Apparently the sediment is cohesive enough that it breaks up along discrete planes. Its properties have been compared to that of wet sand, although the moisture content of the martian sediment is exceedingly low.

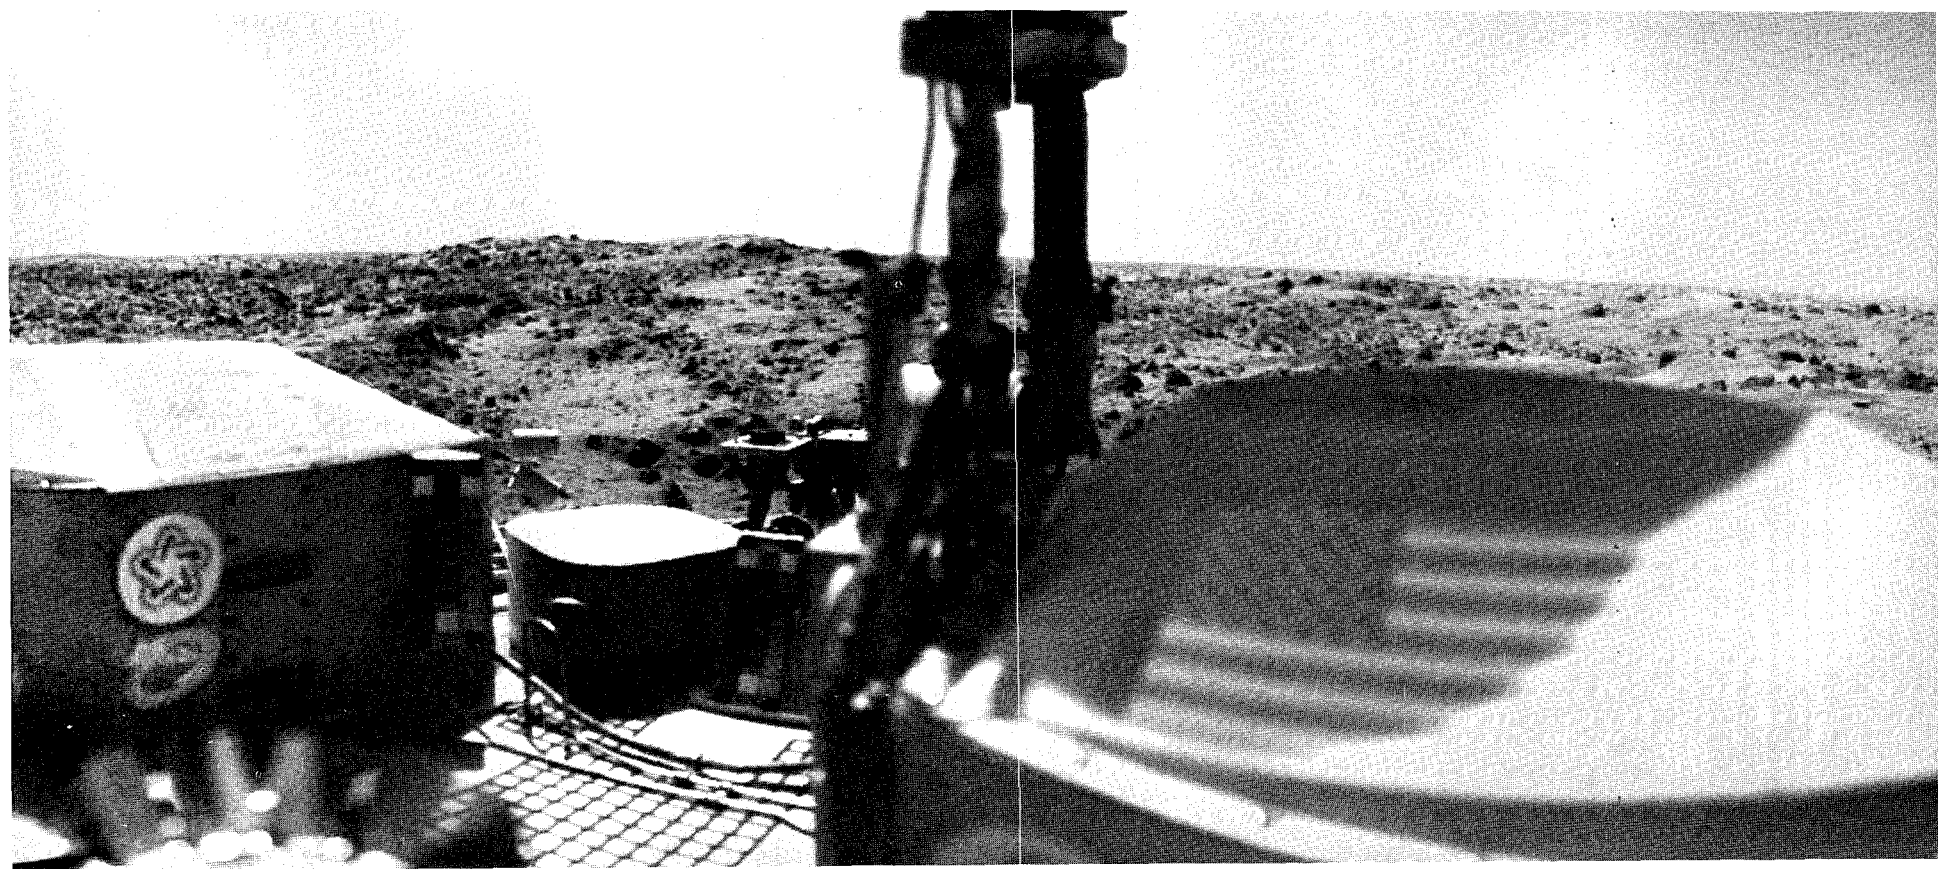
FIGURE 66

These panoramas show the same field of view, looking northwest. Figure 66 was taken in the morning, figure 67 in

mid-afternoon. The wind cover over the radioisotope thermoelectric generator (RTG) is visible in the foreground. Scal-

loped drifts of sediment and clusters of boulders accent the landscape. As in other parts of the scene the larger boul-

ders are localized on small hillocks and appear to be either loci for the accumulation of sediment, or stabilizing elements

for residual sediment. The small parallel ridges in the left half of figure 66 superficially resemble wind-generated ripple

marks, but are probably caused by exposed layering in the drift material.

Particularly well displayed in figures 74 and 76 is a view of the same drift complex shown in figures 66 and 67, although this view is taken with the other camera.

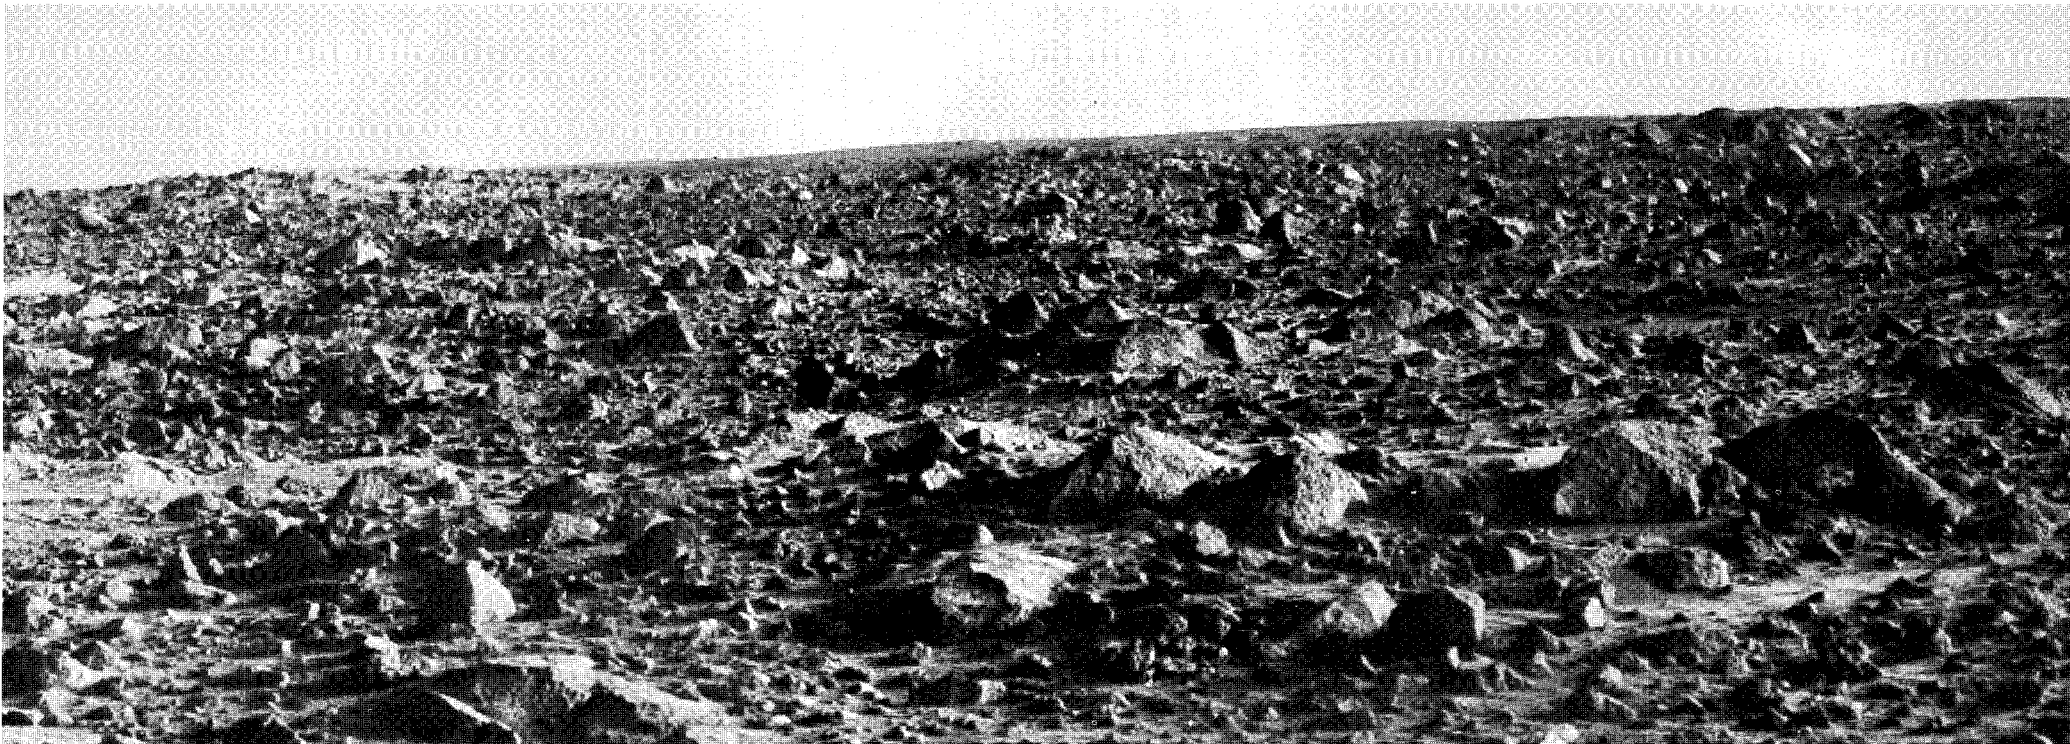
FIGURE 68

This striking panorama shown in two parts (figs. 68 and 69) covers approximately 100° in azimuth. The scene is backlit. The late afternoon Sun is about 18° above the horizon near the middle of the panorama. Some objects on the horizon, as in figure 69, sparkle with reflected light. The top of the low-gain antenna is shown in figure 68. The prominent struc-

The symmetrical ridge on the horizon at the right of figure 68 is a crater rim. It is further described in the text accompanying figures 77 through 79. The origin of the prominent trough in the foreground is undetermined. The higher mound of material in the right half of figure 68 is

about 30 to 60 m from the spacecraft. In fact, it is a complex series of ridges occurring at increasing distances from the spacecraft.

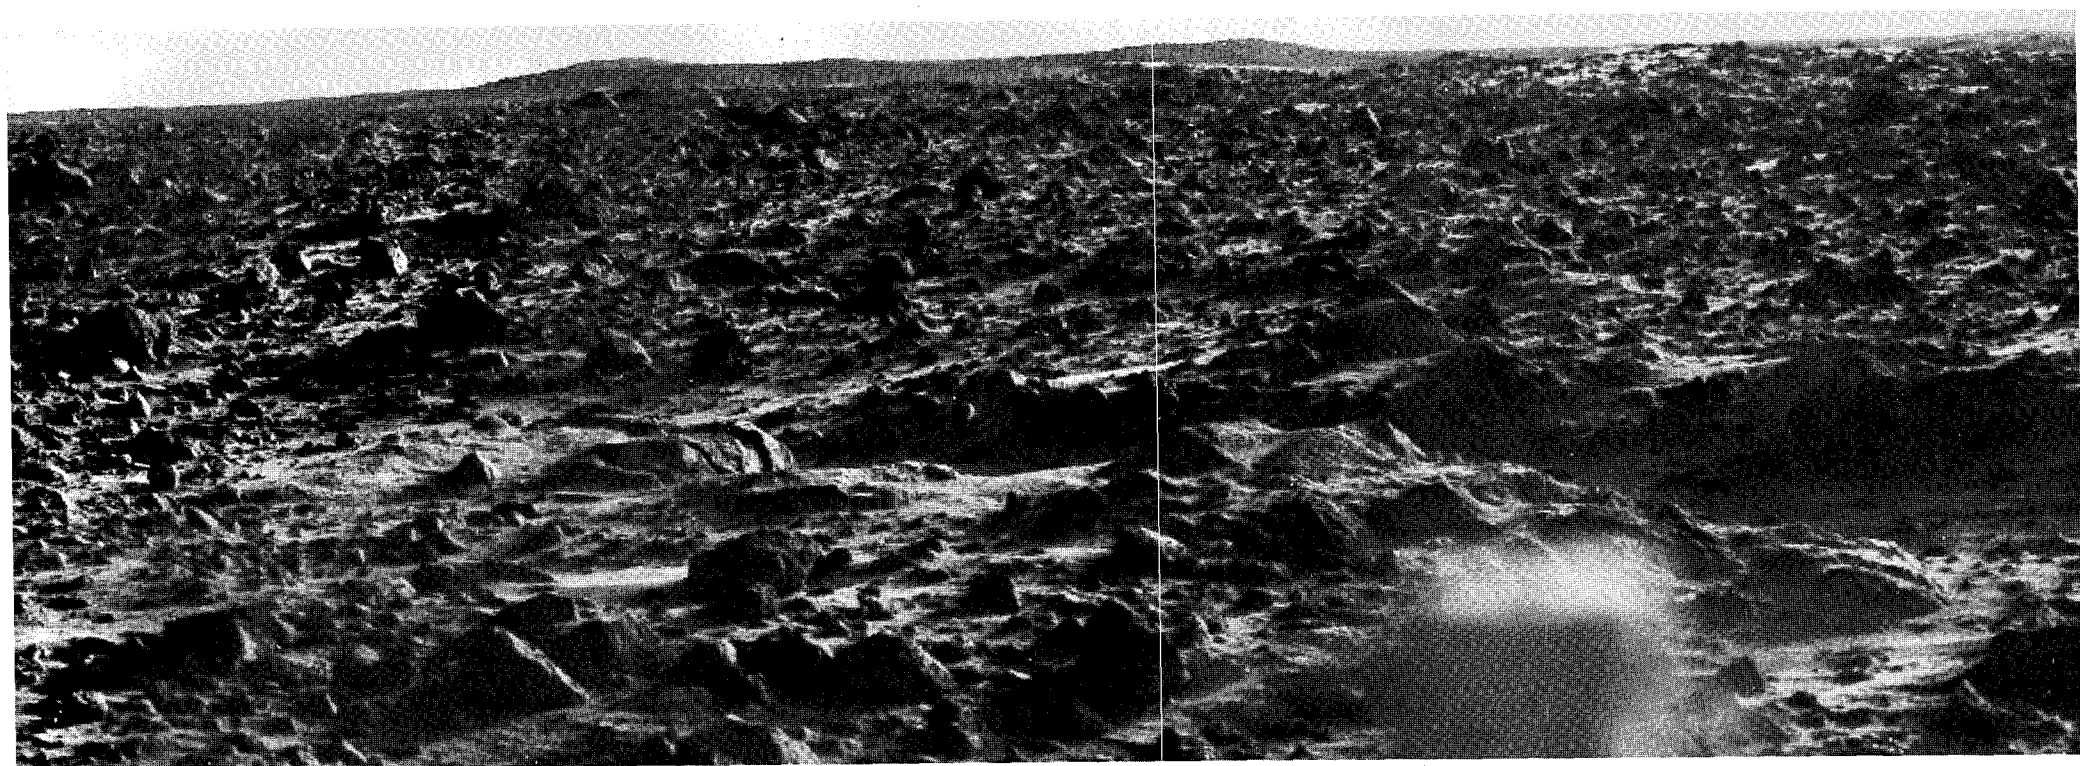
FIGURE 70

ture visible in figures 69 and 70 is the wind cover for the RTG.

A part of the same scene, photographed with early morning light, is shown in figure 70.

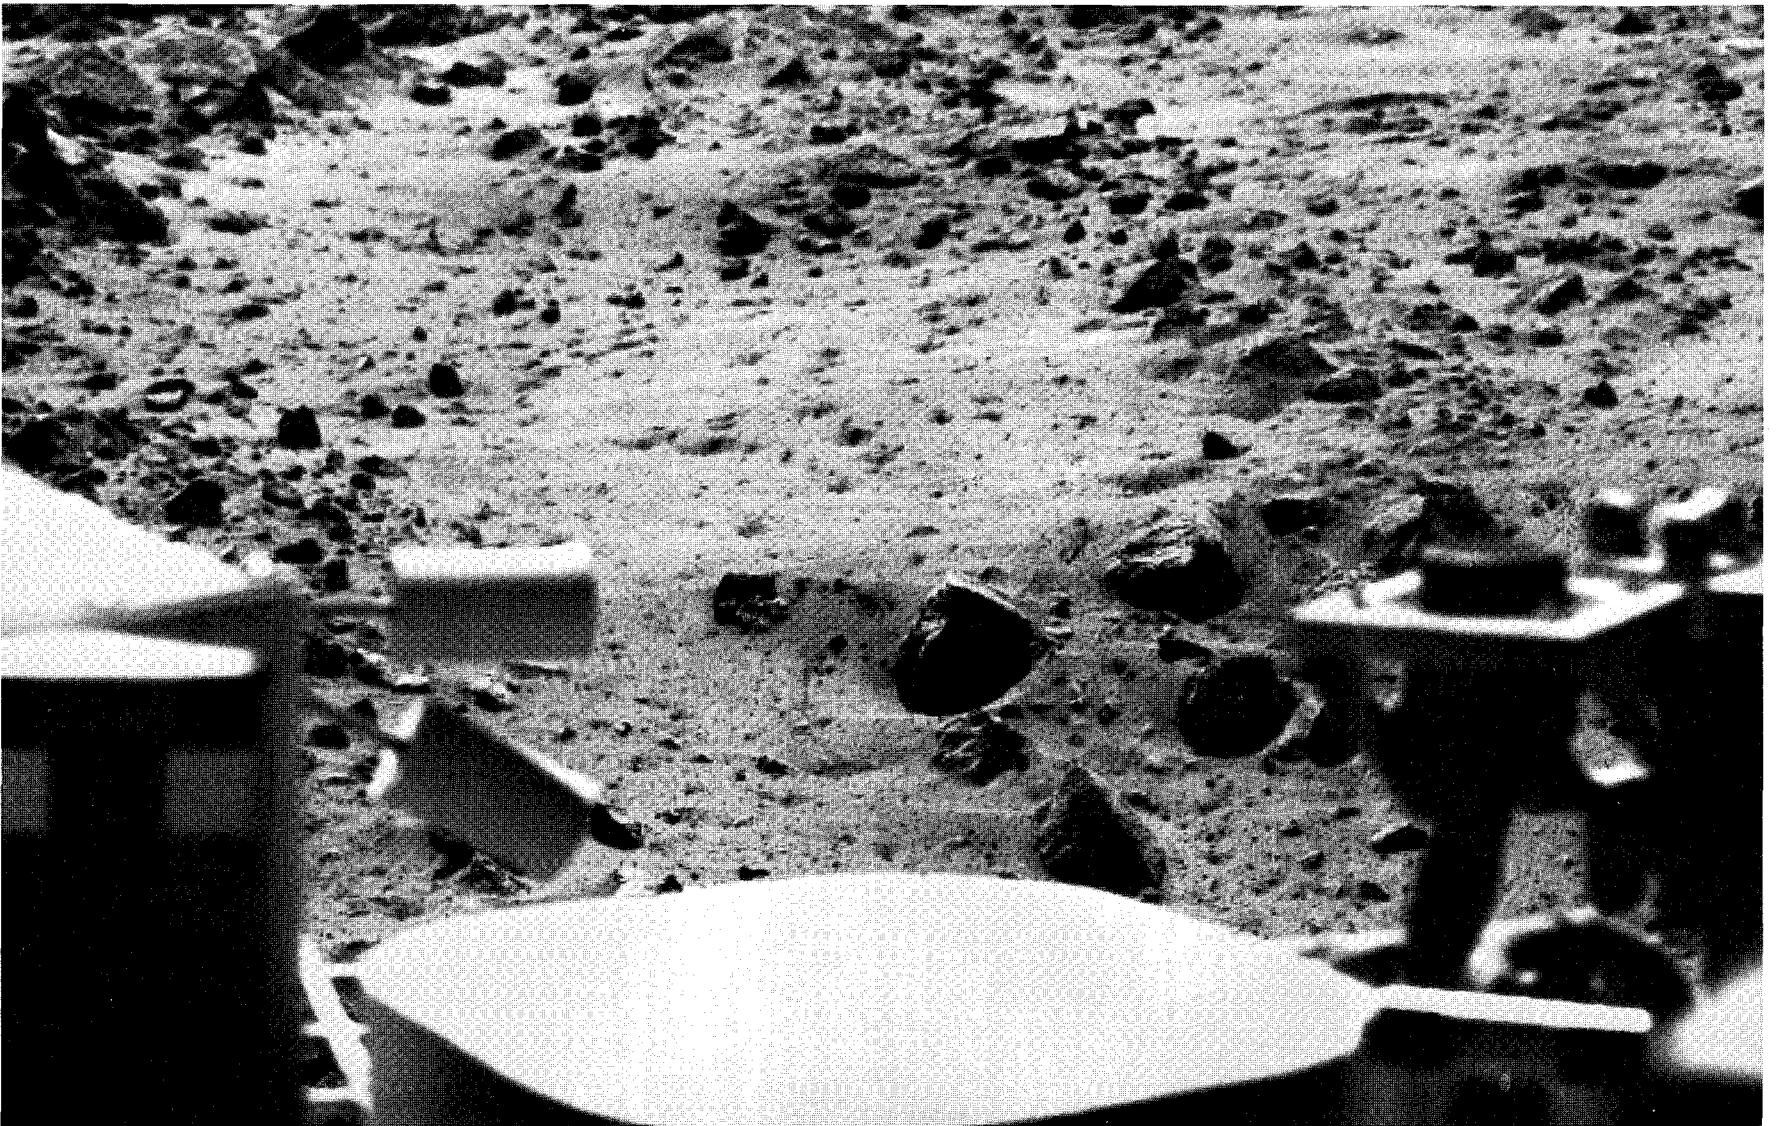
FIGURE 71

These figures dramatically demonstrate the effect of different lighting in revealing detail within the scene. Figure 71 was taken during midday, figure 72 in late afternoon, and figure 73 in early morning. Some of the boulders closest to the spacecraft may have been sculpted by wind-driven sand. Particularly well shown in figure 73 are ripple-like alternations of bright and dark sediment, a probable consequence of wind-sorting and layering during transport.

A part of the UHF antenna that relays Lander data to the Orbiter is shown at the far left. The flat surface at the bottom of the picture is the top of a protective box covering the seismometer. The seismometer on Lander 1 failed to operate, the only significant instrumental failure on either spacecraft. Although the seismometer on Lander 2 worked as anticipated, its ability to detect Mars-quakes was greatly compromised because it was mounted on the upper deck of the spacecraft. Most of the recorded vibrations were induced by wind or by operation of spacecraft components.

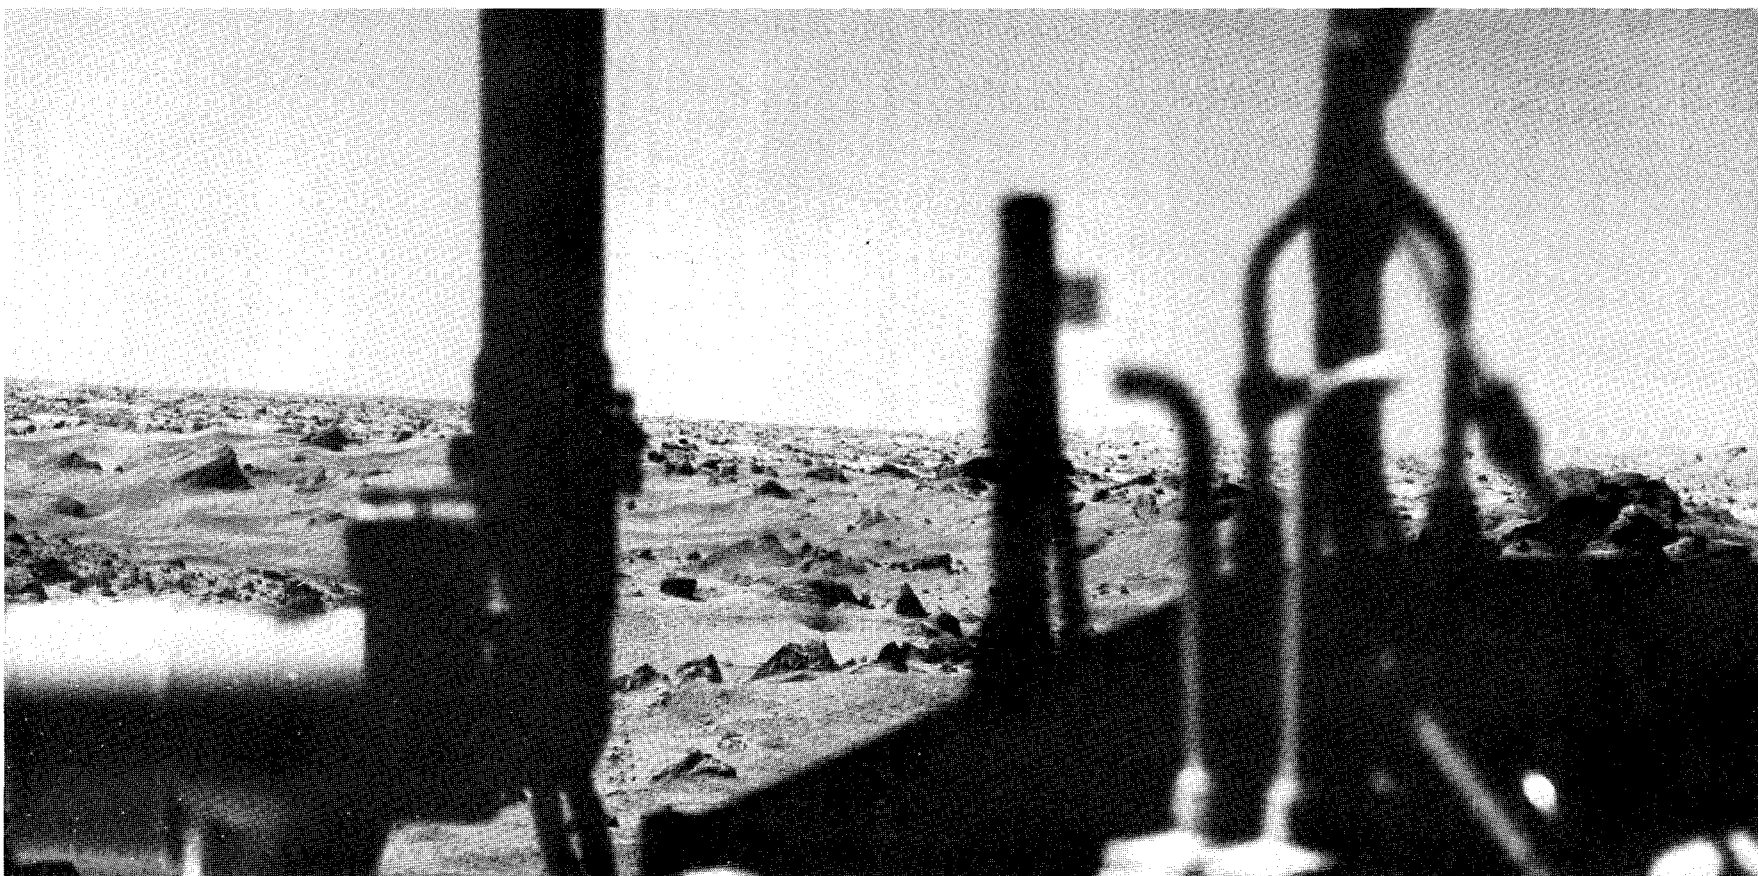
FIGURE 74

Three views (figs. 74 to 76) looking over the Lander through a forest of tubes, most of which served as umbilical cords linking the Lander to the Orbiter during the 10-month journey from Earth to Mars. The unusual graphic effects are reminiscent of a science-fiction illustrator's vision of what a spacecraft on an alien planet *should* look like.

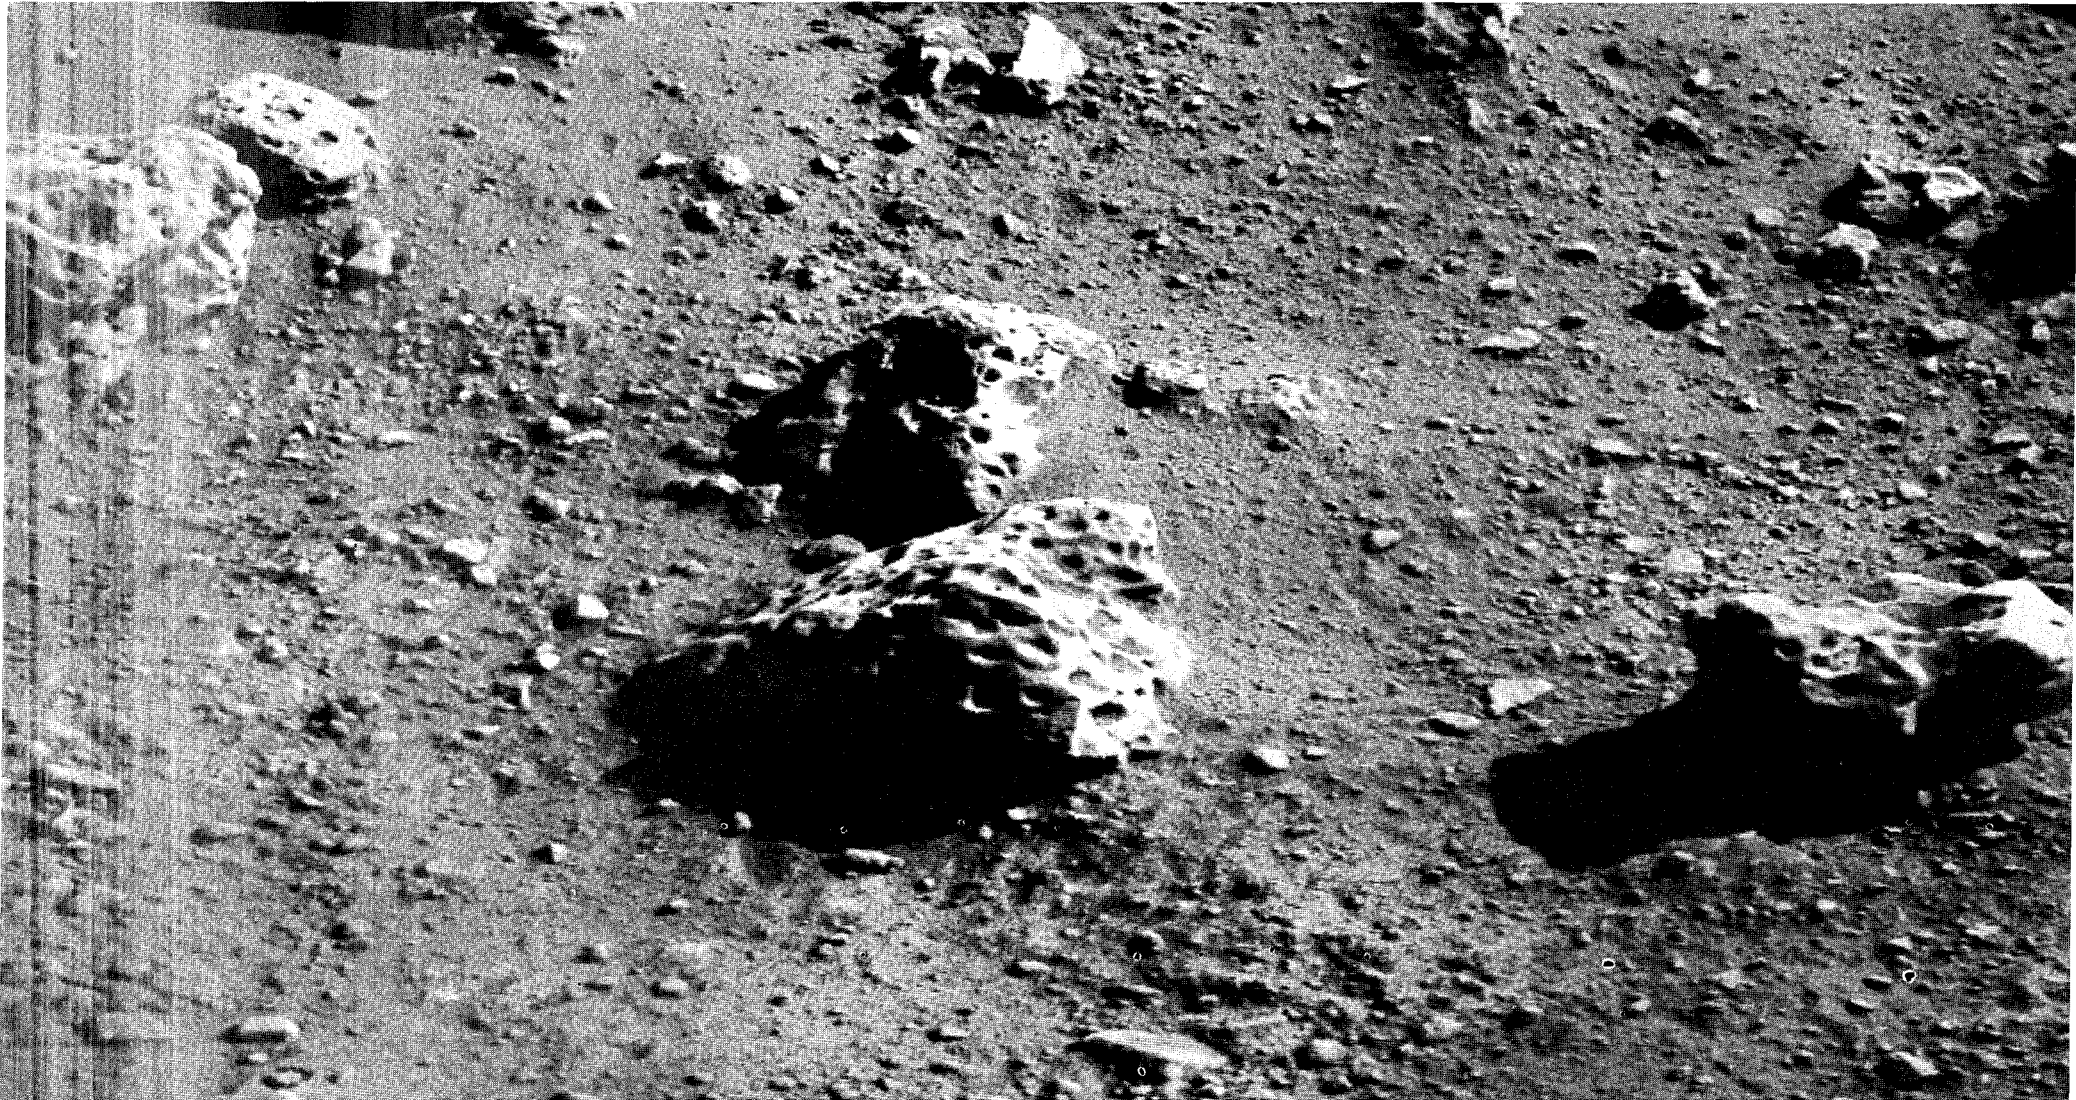
FIGURE 80

Figure 80 is the first picture taken by Viking 2 Lander. The preprogrammed picture sequence for the first several days was nearly identical to that stored in the Lander 1 computers (fig. 19); to that extent, certain aspects of the Viking 1 and 2 pictures are similar. Note, for example, the vertical streaking at the left side of figure 80. In general, this is very similar to the streaking in the first Viking Lander 1 picture. It occurs in none of the more than 3000 other pictures taken throughout the mission, including a later view of the same area (fig. 81). This evidence conclusively demonstrates that the streaking is the result of a singular event—raising of a dust cloud at the time

of touchdown. The detailed configuration of streaking at the two landing sites is different, indicating slightly different dissipation of the dust. At the Lander 1 site the atmosphere was clear after 1½ min. At the Lander 2 site the dust settled more rapidly; clearing was complete within one min.

We had expected (hoped?) that the second landing site would be relatively free of blocks. This first picture made our predictions look a little shaky. The sponge-like rock in the right half of figure 80 provides a dramatic example of vesicular texture. The subspherical cavities probably formed around small gas bubbles in cooling volcanic lava.

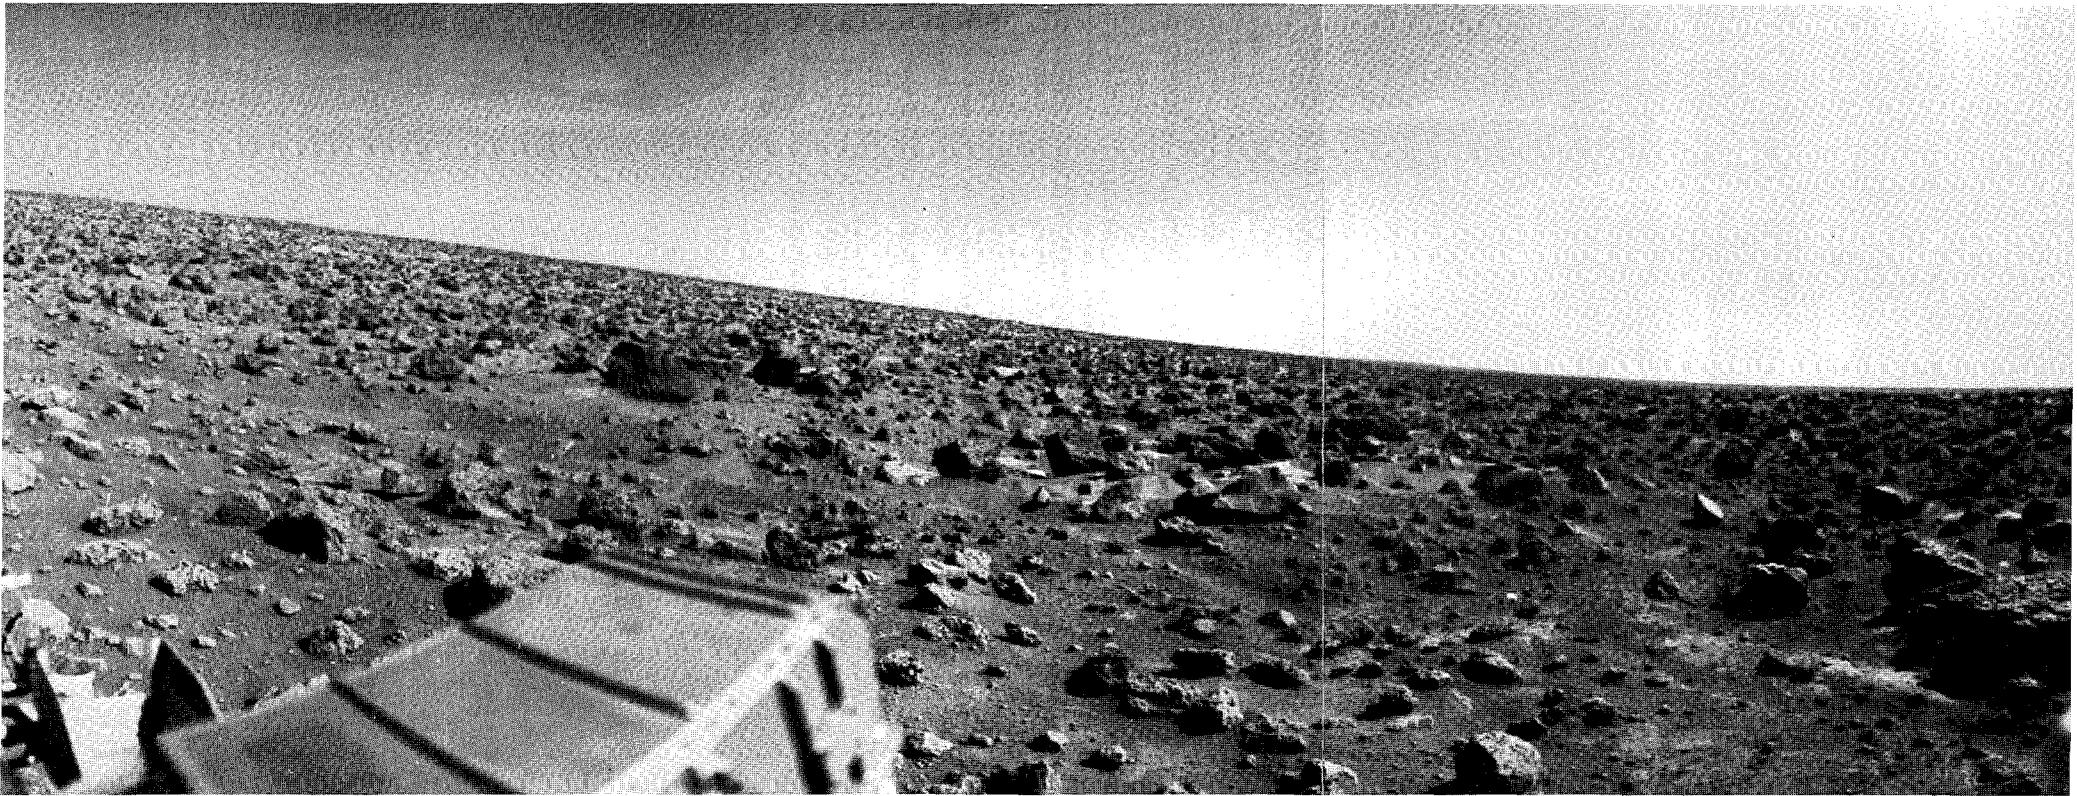
FIGURE 82

Figure 82 is the second picture taken by Lander 2, a low-resolution panorama that was completed about 20 min after touchdown. The most striking feature is the sloping horizon. Recall that the picture is assembled from left to right. As we looked at the first few lines all we could tell was that the horizon dipped to the right. Although it was possible that this was an actual feature within the scene, we suspected otherwise. As the image continued and we watched the horizon regularly descend and then climb back up our suspicions were confirmed. The horizon was, in fact, very nearly level but the spacecraft was tilted approximately 8° toward the northwest. The effective result is that in the middle of the panorama, looking toward the southeast, the camera is tilted up and the horizon appears near the bottom of the

image. Pointing in the opposite direction, northwest, the camera's field of view is tilted downward and the horizon appears near the top of the image.

Note the bright streak in the sky. The fact that it is horizontal, even though the horizon is tilted, indicates that it is not an atmospheric effect but is due to spurious camera reflections, as described in figure 24. This interpretation is further confirmed by the fact that the "cloud" passes in *front* of the S-band antenna.

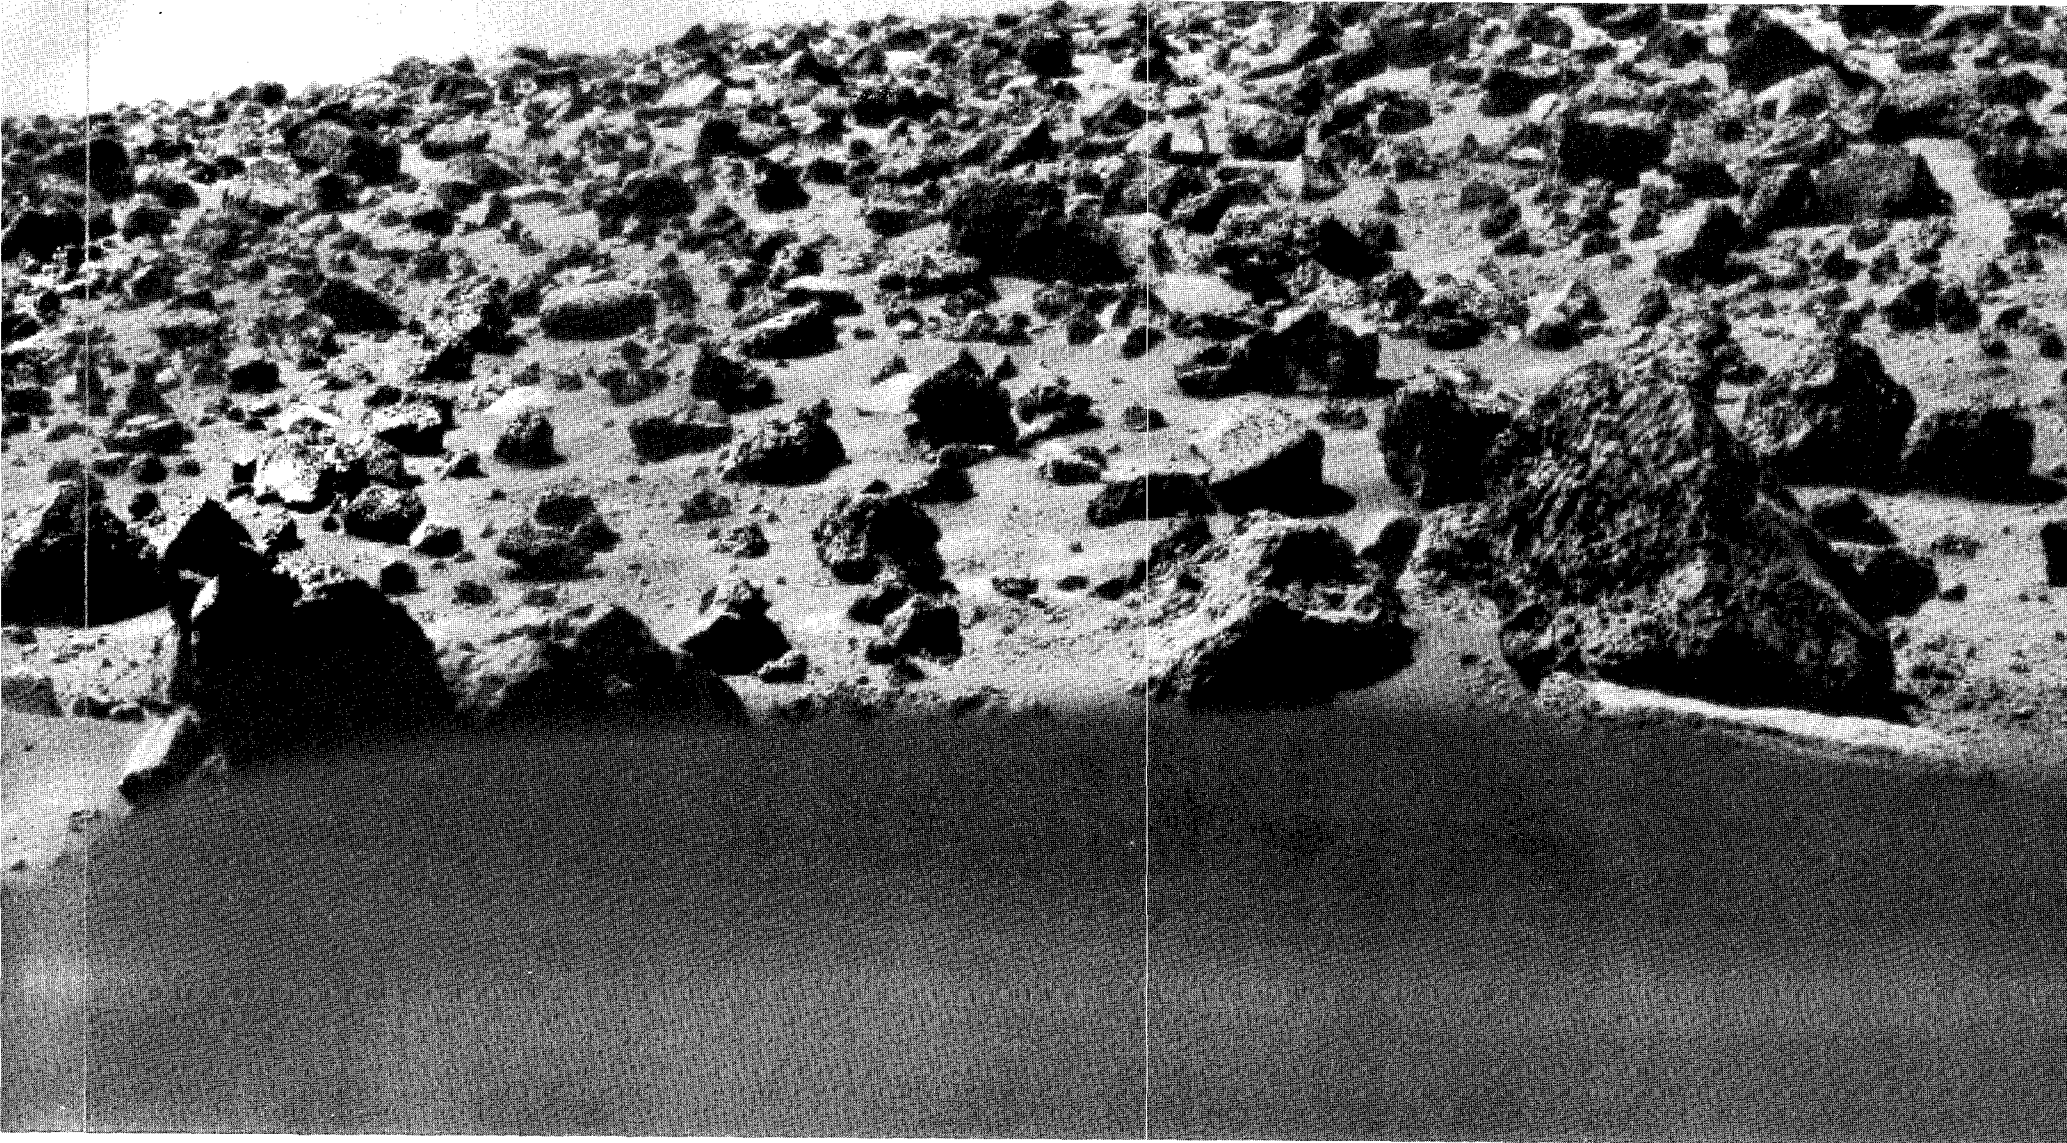
FIGURE 85

Two views of the same rock-strewn plain are shown. Figures 83 and 84 were taken in the early morning. The Lander faces approximately northeast. With lighting from the east the S-band antenna, mounted on the rear of the spacecraft, casts a shadow on the ground to the left of the Lander. Figure 85 was taken at noon.

The many boulders seem to stand apart from the bland background, as if they were carefully positioned on some giant Hollywood set. This appearance probably is due to erosion by wind—eolian deflation, in geological parlance—that has carried away fine-grained material between larger rocks. Some of the boulders actually stand on pedestals of protected fine-grained substrate.
